The following is a procedure to upgrade the V72 Host Modules in your M9 units. These changes may be made while the unit is in place, but will require a laptop computer with a communications package (PROCOMM, Hyper Terminal, etc) installed, plus a crossed RJ-45 cable and a BayTech PC4 adapter. The cable and adapter came with the units.

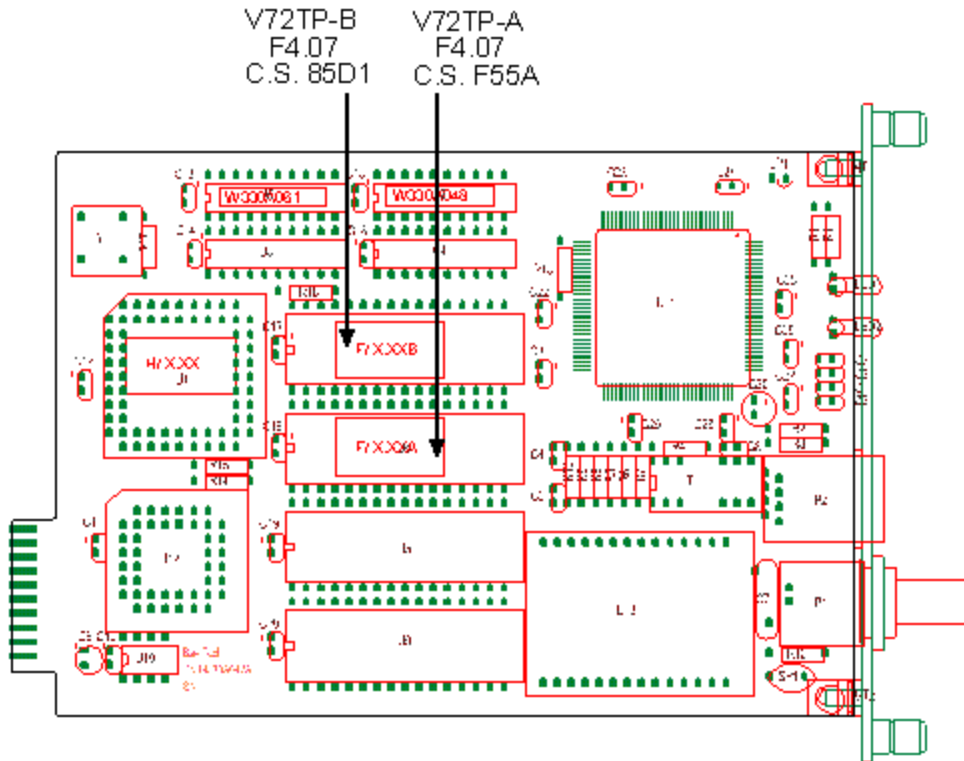
The drawing below shows the location of the “A” and “B” EEPROMS. The notch should be on the end nearest the card contact fingers and should be installed to the far right of the socket.

κ Turn the unit off, remove the V72 Host Module, and replace the EEPROMS with the versions you received. The new versions are labeled:

V72TP-A	V72TP-B
F 4.07	F 4.07
C.S. F55A	C.S. 85D1
